Item 8.1

ITEM	SUBJECT	PAGE NO
8.1	MOOLOOLABA FORESHORE REVITALISATION - STAGE TWO CENTRAL MEETING PLACE AND SOUTHERN SEAWALL	
ATTACHMENT 1	STRUCTURAL ENGINEERING INSPECTION AND ASSESSMENT LOO WITH A VIEW STRUCTURE	5
ATTACHMENT 2	STRUCTURAL ASSESSMENT LOO WITH A VIEW MOOLOOLABA BEACH	13
ATTACHMENT 3	MOOLOOLABA BUSINESS ACTIVATION GROUP TERMS OF REFERENCE	29
ATTACHMENT 4	MOOLOOLABA STAKEHOLDER INTEREST GROUP TERMS OF REFERENCE	39
ATTACHMENT 5	MOOLOOLABA FORESHORE STAGE TWO PLAN.....	49
ATTACHMENT 6	MOOLOOLABA FORESHORE STAGE TWO COMMUNITY ENGAGEMENT REPORT	51
ATTACHMENT 7	COASTAL HAZARD ADAPTATION STRATEGY PARTS A & B MOOLOOLABA SECTION.....	177

STRUCTURAL ENGINEERING INSPECTION AND ASSESSMENT**LOO WITH A VIEW STRUCTURE**15th December 2023**Overview:**

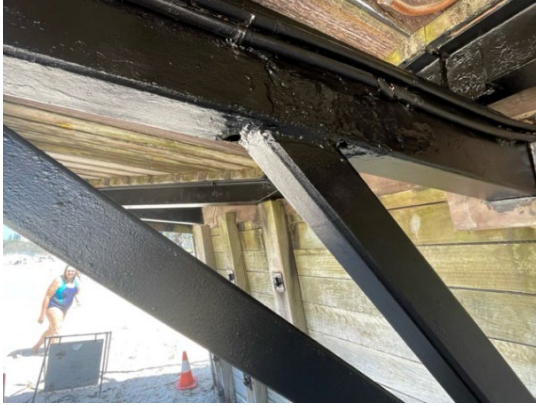
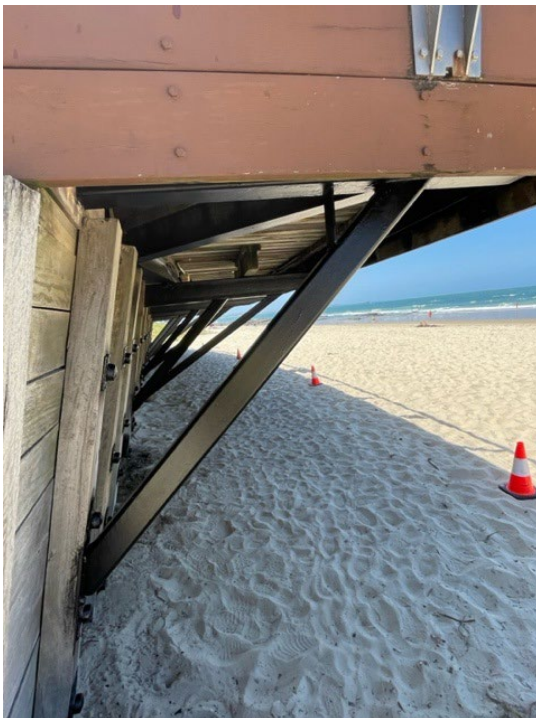
Remedial works carried out in the last two years are now starting to rust.

1. Steel structure was sanded back and treated with rust converter and then repainted with two-part epoxy corrosion protective paint.

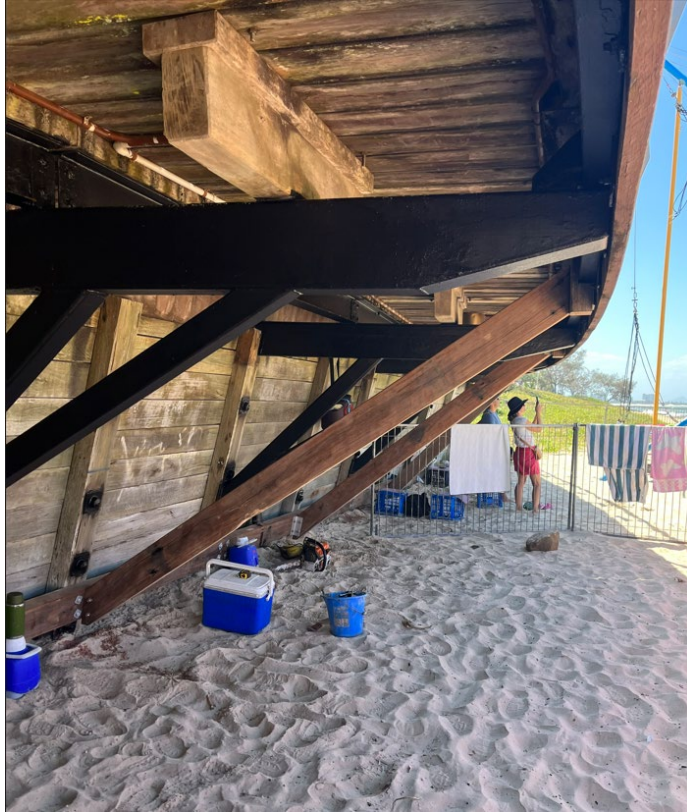
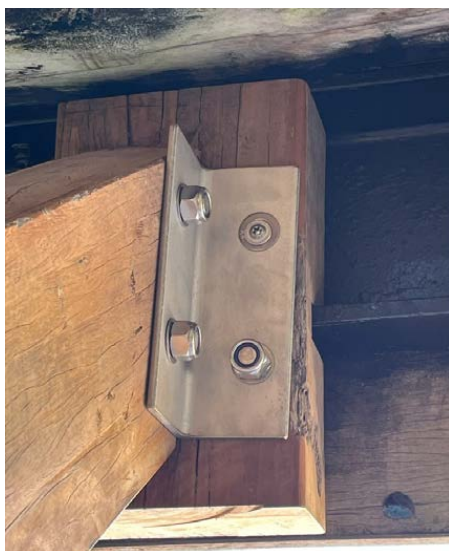
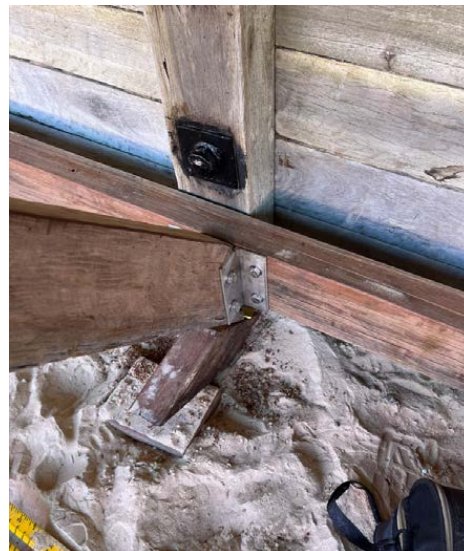
The cantilevered timber deck that overhangs the beach continues to degrade at a rapid rate.

2. Timber props/bracing have been installed to support the deck overhang, with council officer confirming the temporary bracing is solid after a brief look on 14th December 2023.
